Guide to Traffic Impact Assessment Case Studies

Case Studies

1. Case study 1: Urban context – impacts on over capacity base network
2. Case study 2: Large hardware retailer in under capacity road network
3. Case study 3: Large quarry in rural area
4. Case study 4: Small residential development in under capacity road network

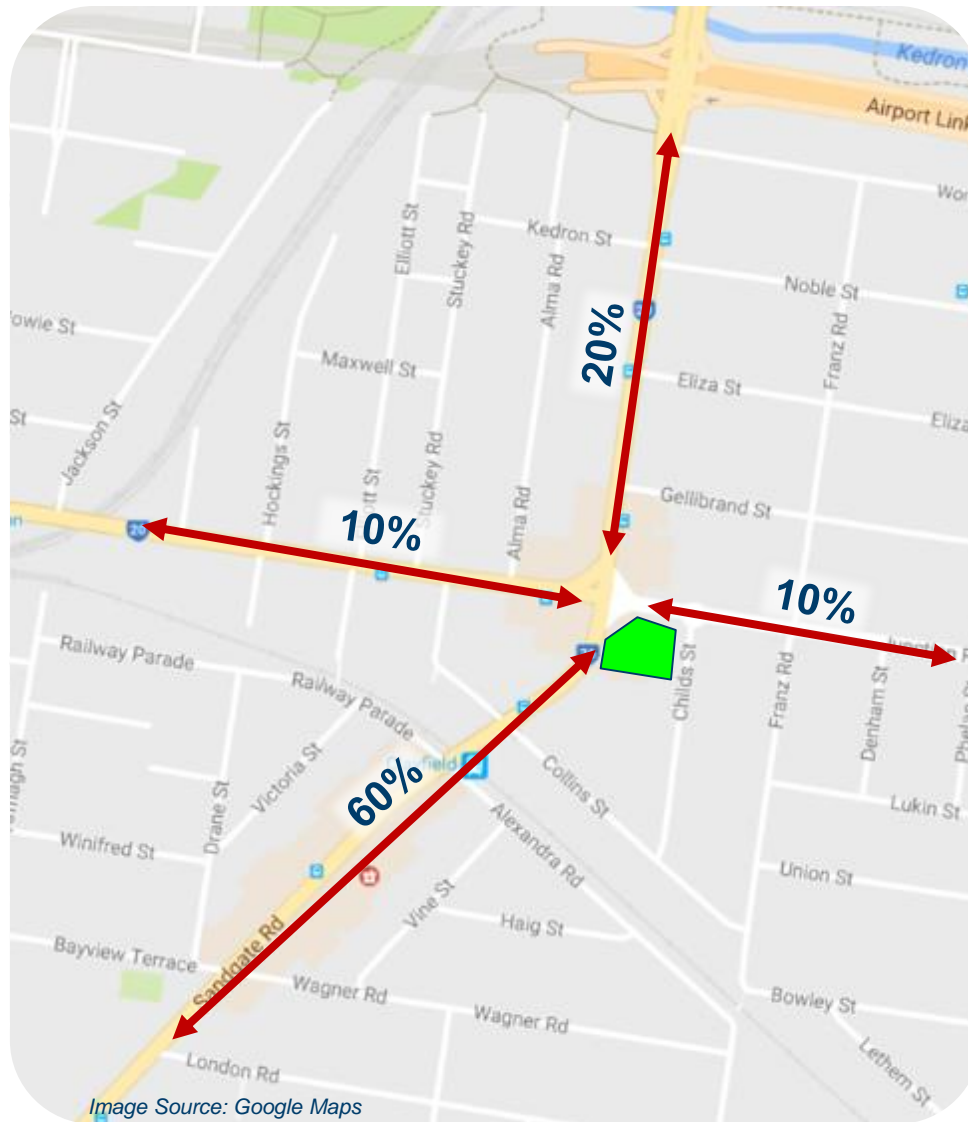
Step 4: Development traffic

TIA Item	Assessment
Development Traffic Volumes on Network	✓
Notes: Distribution is based on: ❖ <i>Traffic Survey Data</i>

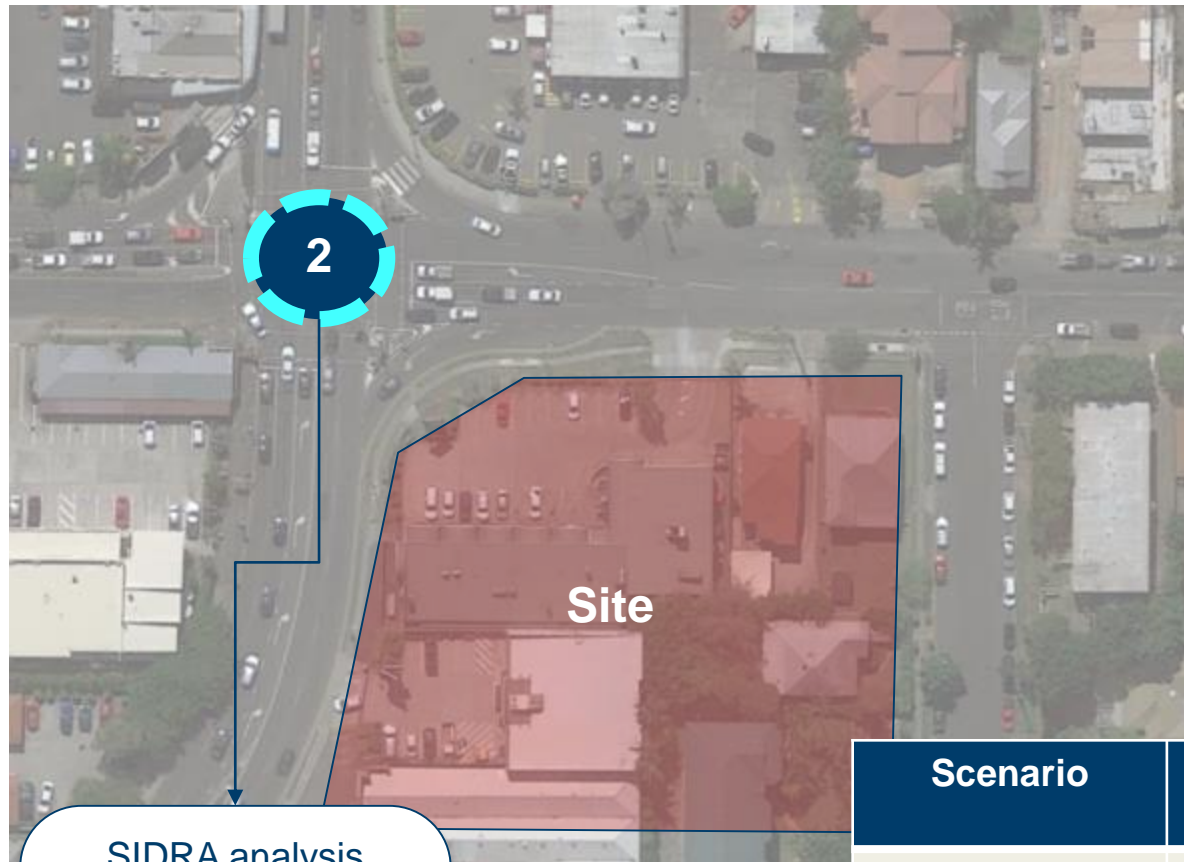
SIDRA analysis required as development traffic is greater than 5% of 2018 background traffic on a number of movements

Scenario	Intersection Delay
2018 Background	45.0 seconds
2018 With Development	54.0 seconds
% Difference	20% <u>increase</u> in delay

Delay impact is > 5% Investigate "Avoid, Manage or Mitigate" options

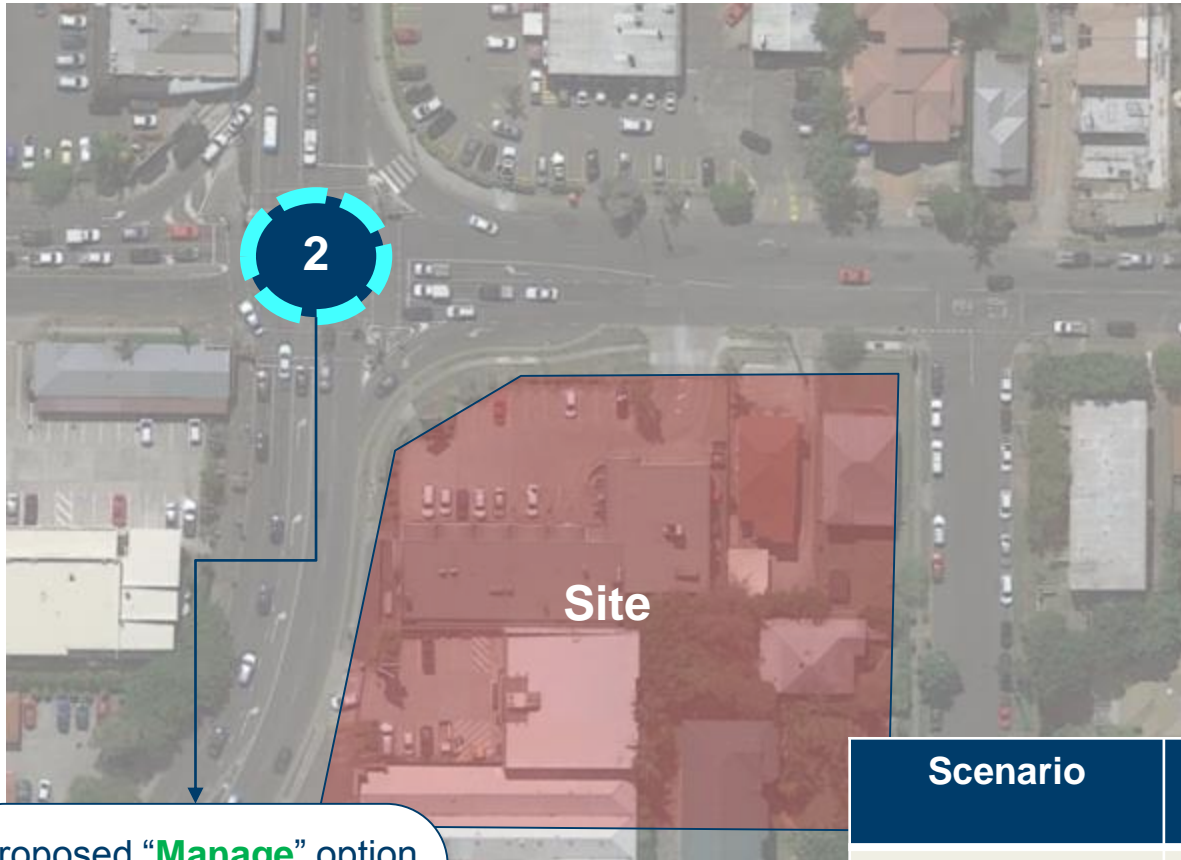
Proposed “**Manage**” option to include a reduction in on-site car parking as a Travel Demand Measure (TDM) – **reduces development trip generation by 15%**

Scenario	Intersection Delay
2018 Background	45.0 seconds
2018 With Development + TDM	50.0 seconds
% Difference	9% <u>increase</u> in delay

**Delay impact remains > 5%
Investigate further options to reduce delay impact**

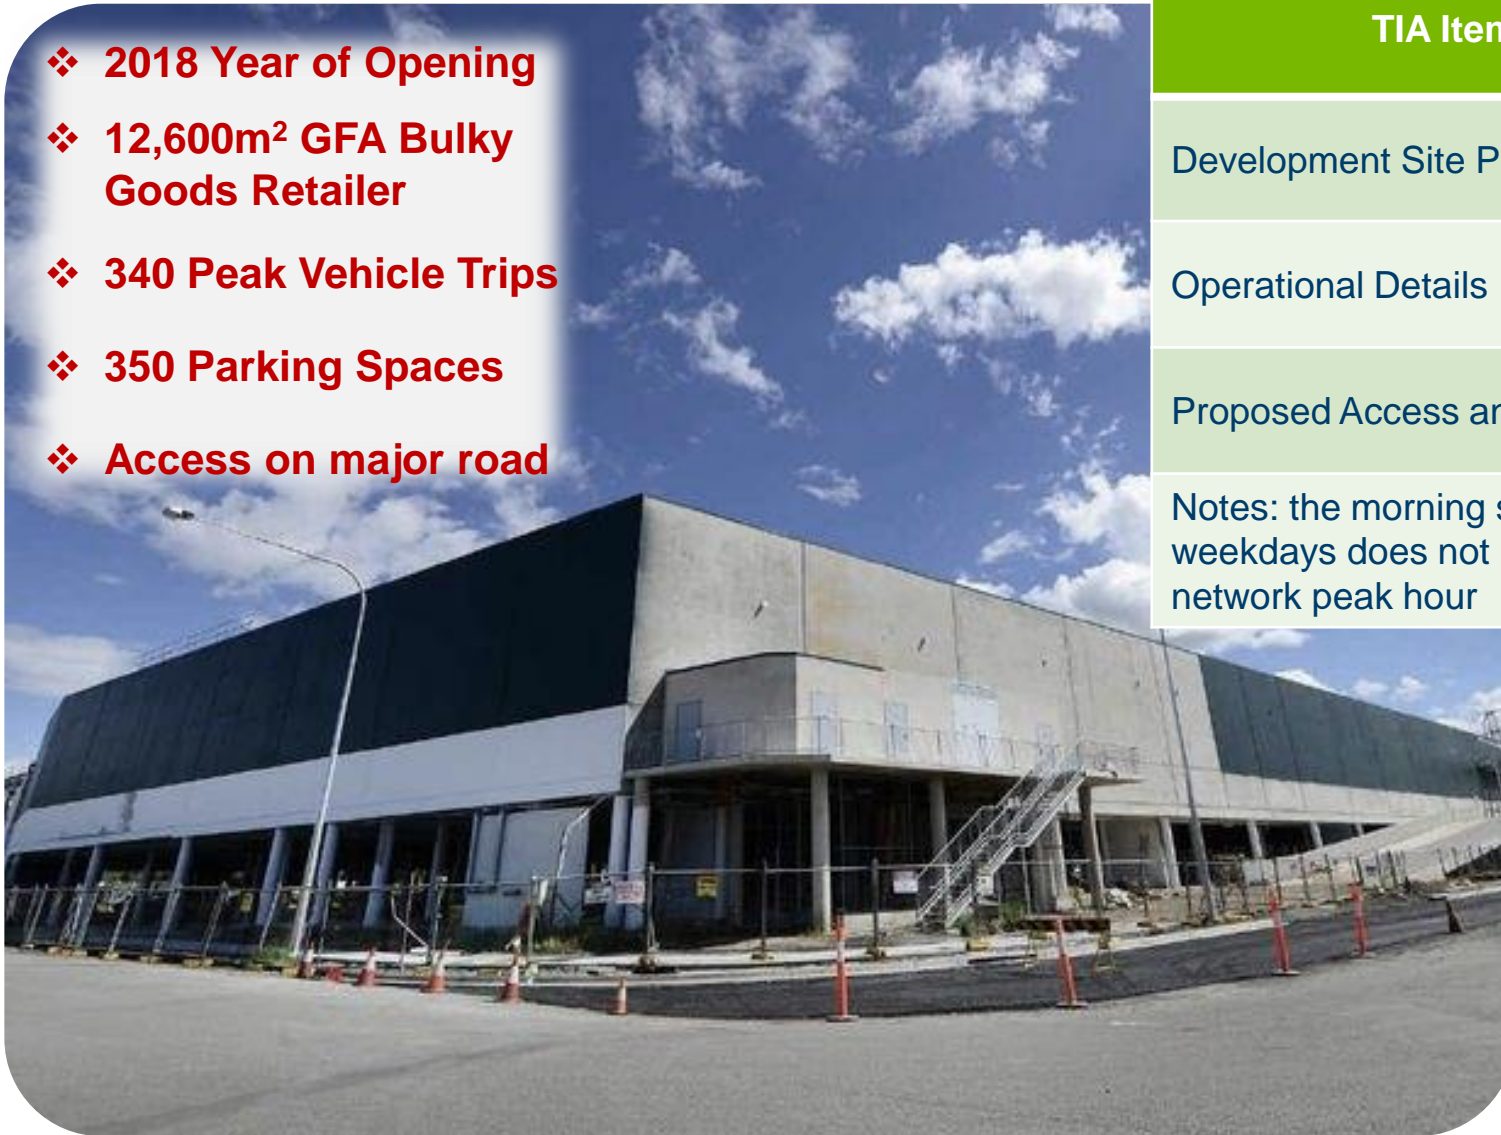
Step 3: Proposed development details

- ❖ **2018 Year of Opening**
- ❖ **12,600m² GFA Bulky Goods Retailer**
- ❖ **340 Peak Vehicle Trips**
- ❖ **350 Parking Spaces**
- ❖ **Access on major road**

TIA Item	Assessment
Development Site Plan	✓
Operational Details	✓
Proposed Access and Parking	✓
Notes: the morning site peak hour during weekdays does not generally coincide with the network peak hour

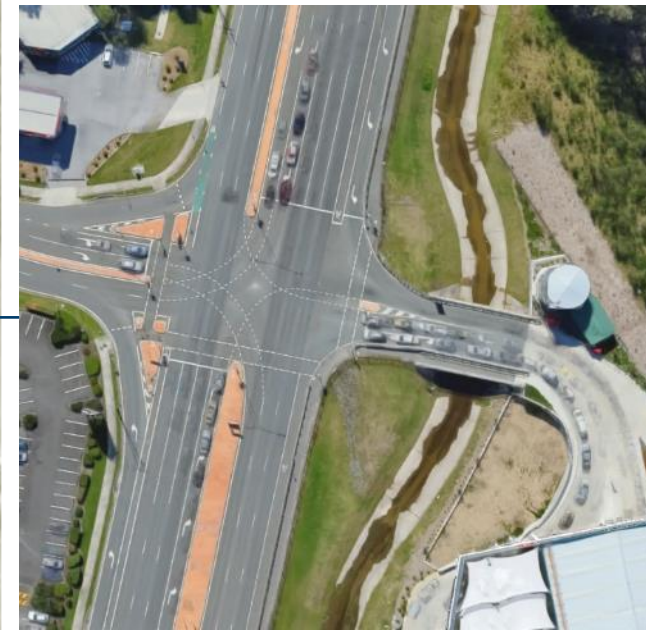
The development site proposes Channelised Right-turn (CHR) and Channelised Left-turn (CHL) lane treatments plus upgrade to existing signals to gain access to Bermuda Street

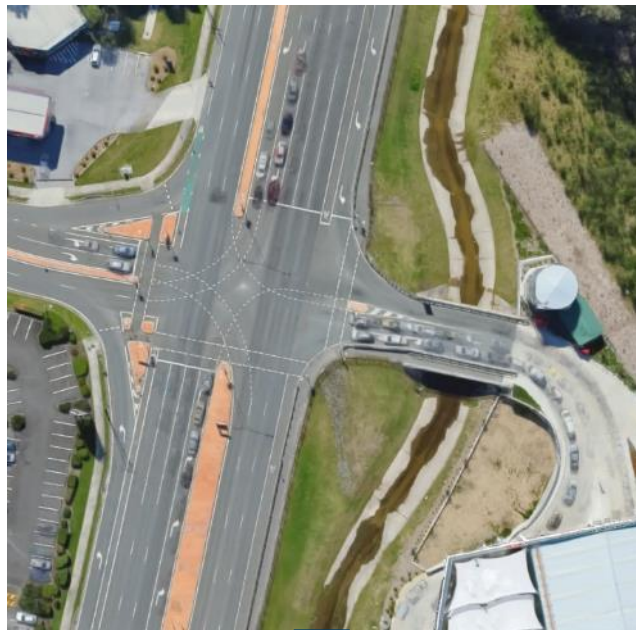
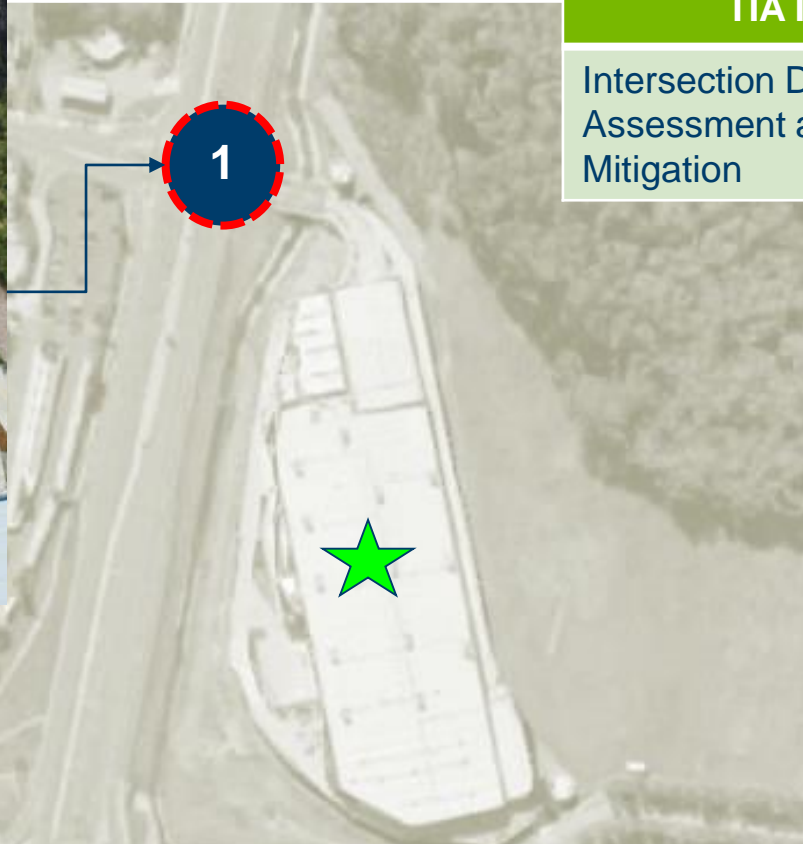
Access must operate within acceptable performance limits (degree of saturation, delay and queues) for a 10-year design horizon

Scenario	Within Acceptable Limits?
2018 With Development	✓
2028 With Development	✓

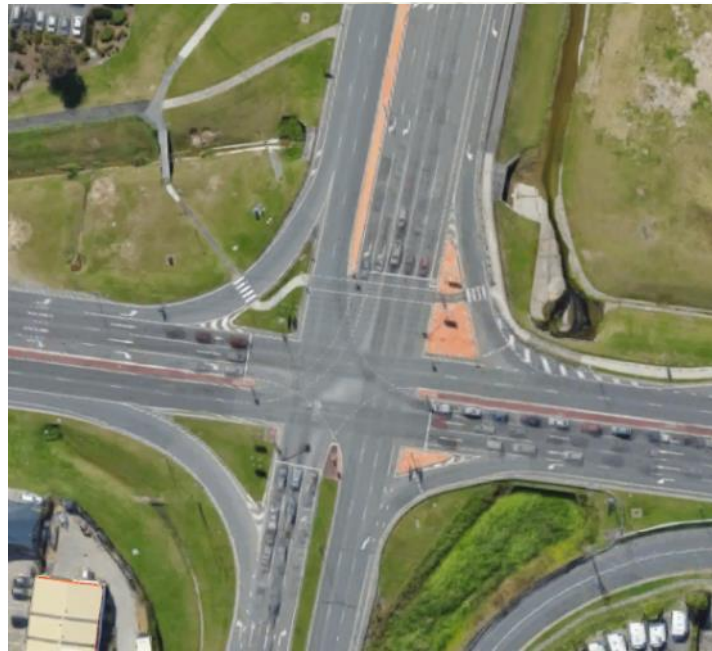
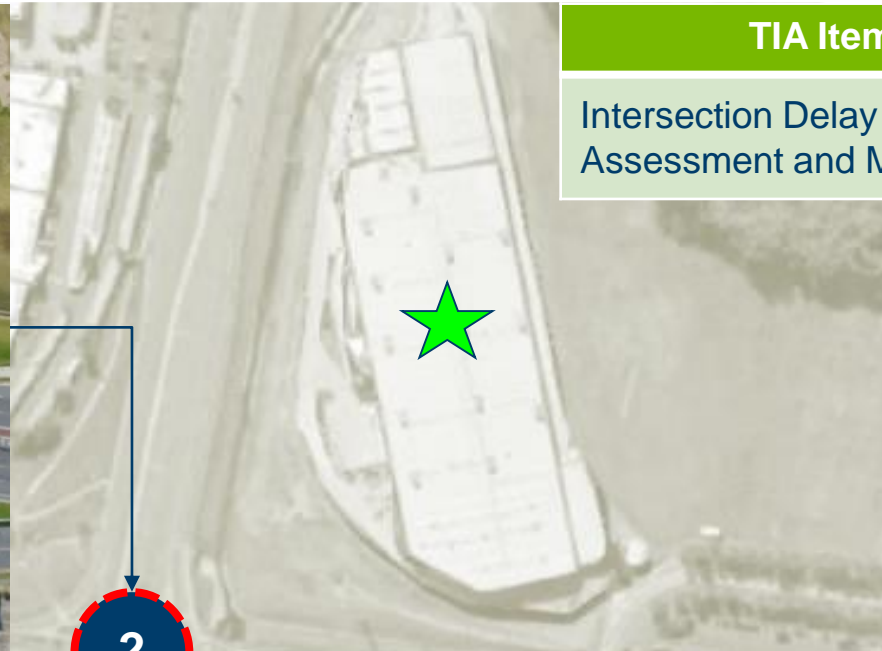
SIDRA analysis required as development traffic is greater than 5% of 2018 background traffic on a number of movements

Scenario	Intersection Delay
2018 Background	30.0 seconds
2018 With Development	36.0 seconds
Percentage difference	20% increase in delay

Delay Impact is > 5% Investigate "Avoid, Manage or Mitigate" options to reduce delay impact

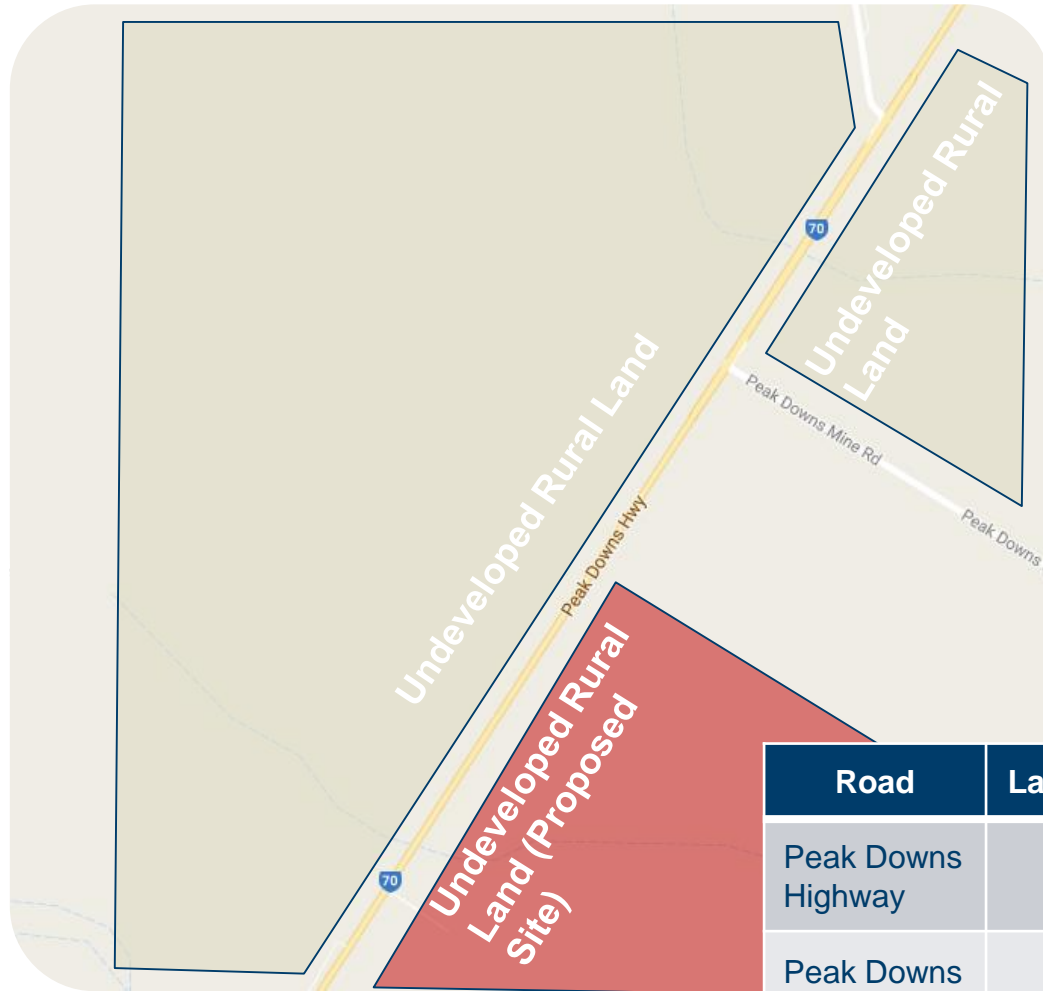
Step 2: Existing conditions

TIA Item	Assessment
Land use and Zoning	✓
Adjacent Land Uses/ Approvals	✓
Surrounding Road Details	✓

Road	Lanes	Jurisdiction	Divided	Speed	Comment
Peak Downs Highway	2	TMR	No	100kph	State Highway
Peak Downs Mine Road	2	Council	No	80kph

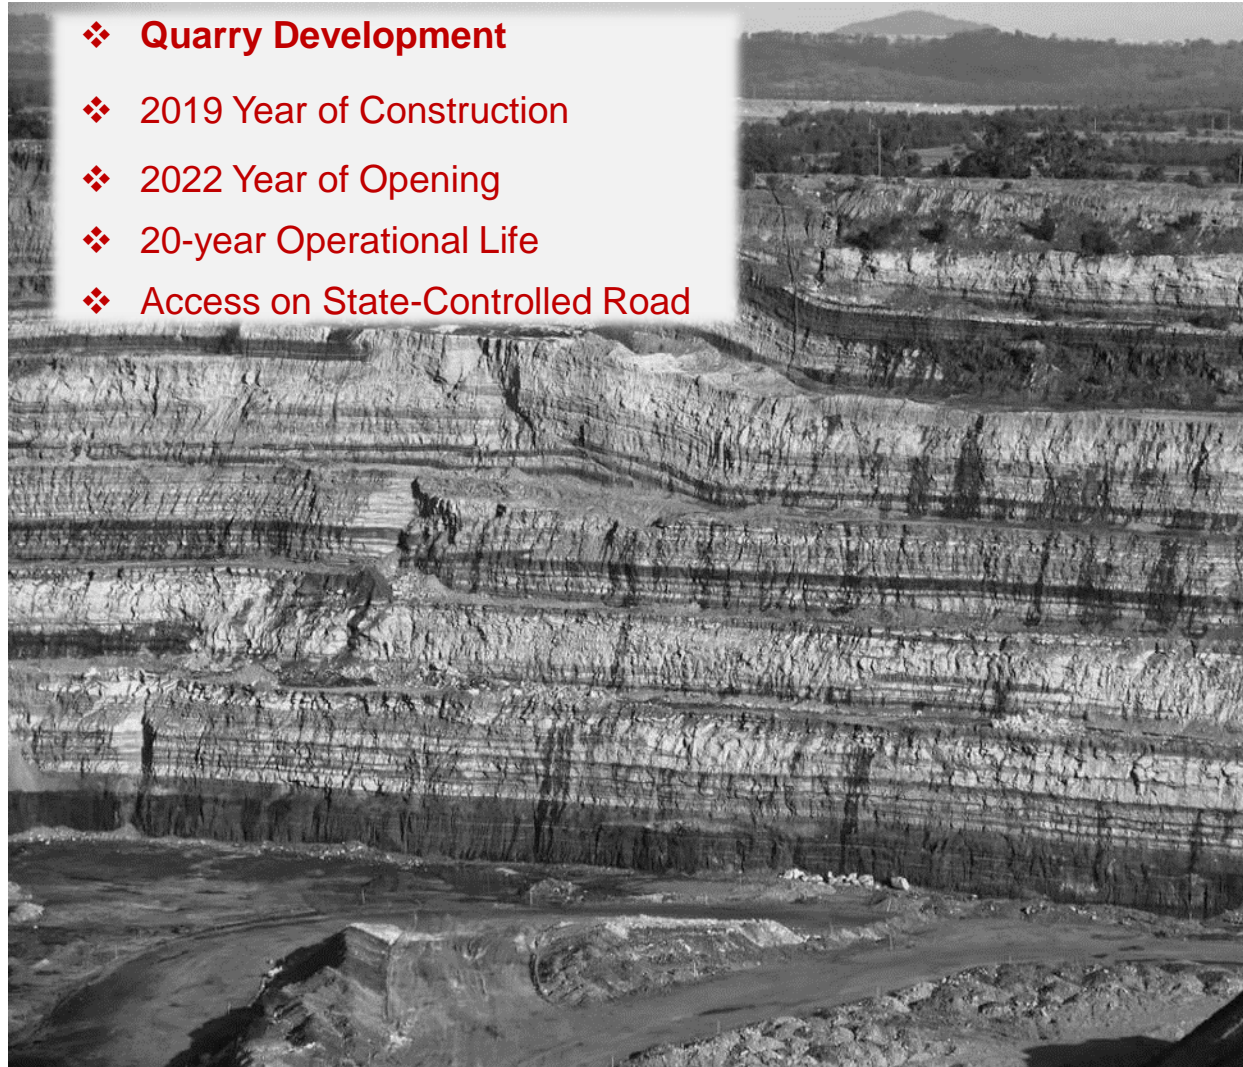
Step 3: Proposed development details

TIA Item	Assessment
Development Site Plan	✓
Operational Details	✓
Proposed Access and Parking	✓

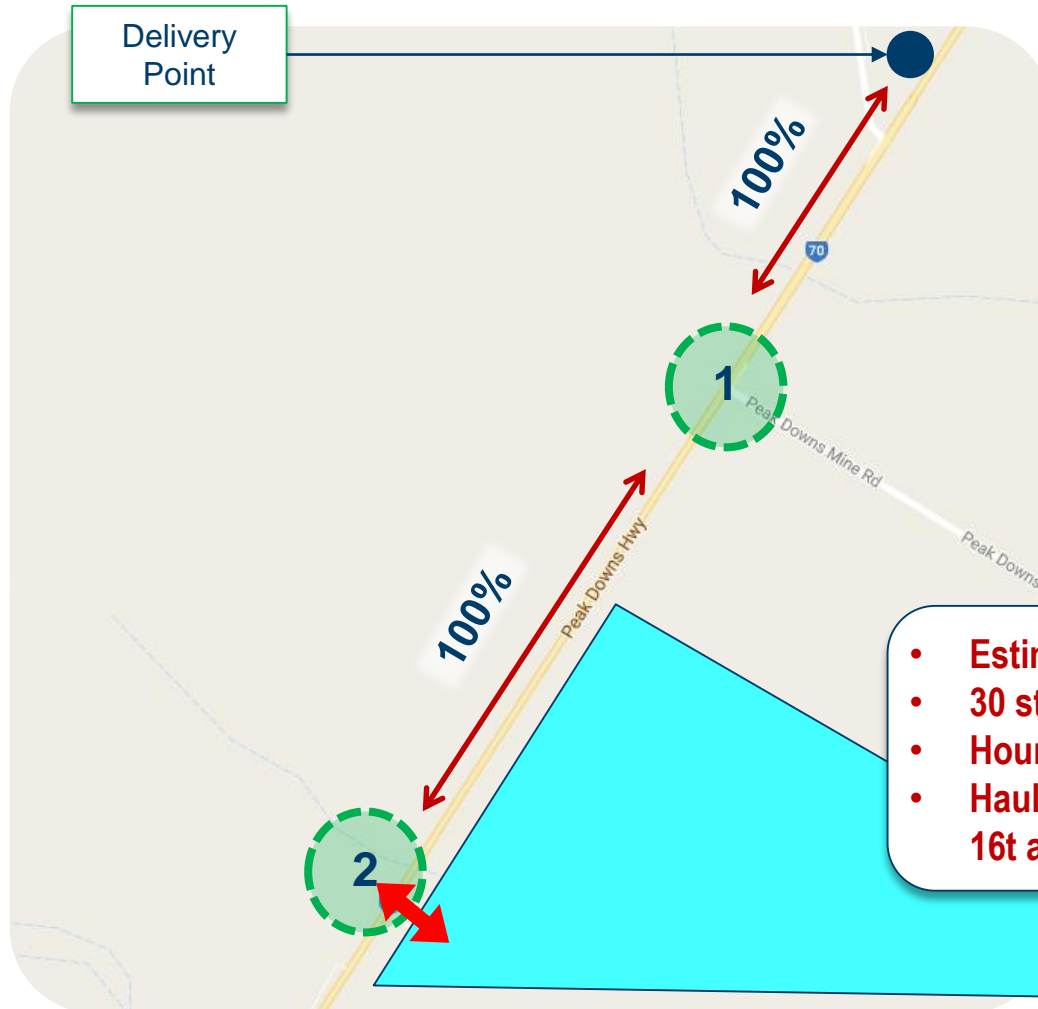
TIA Item	Assessment
Development Traffic Volumes on Network	✓
Notes: Distribution is based on: - <i>Delivery point</i>

- **Estimated quarry output = 250,000 tonnes / year**
- **30 staff present during construction and operation phases**
- **Hours of operation = 6am to 6pm, Monday to Friday**
- **Haulage via 42.5t GVM tri-axle semi tippers with a tare of 16t and net payload weight of 26.5t**

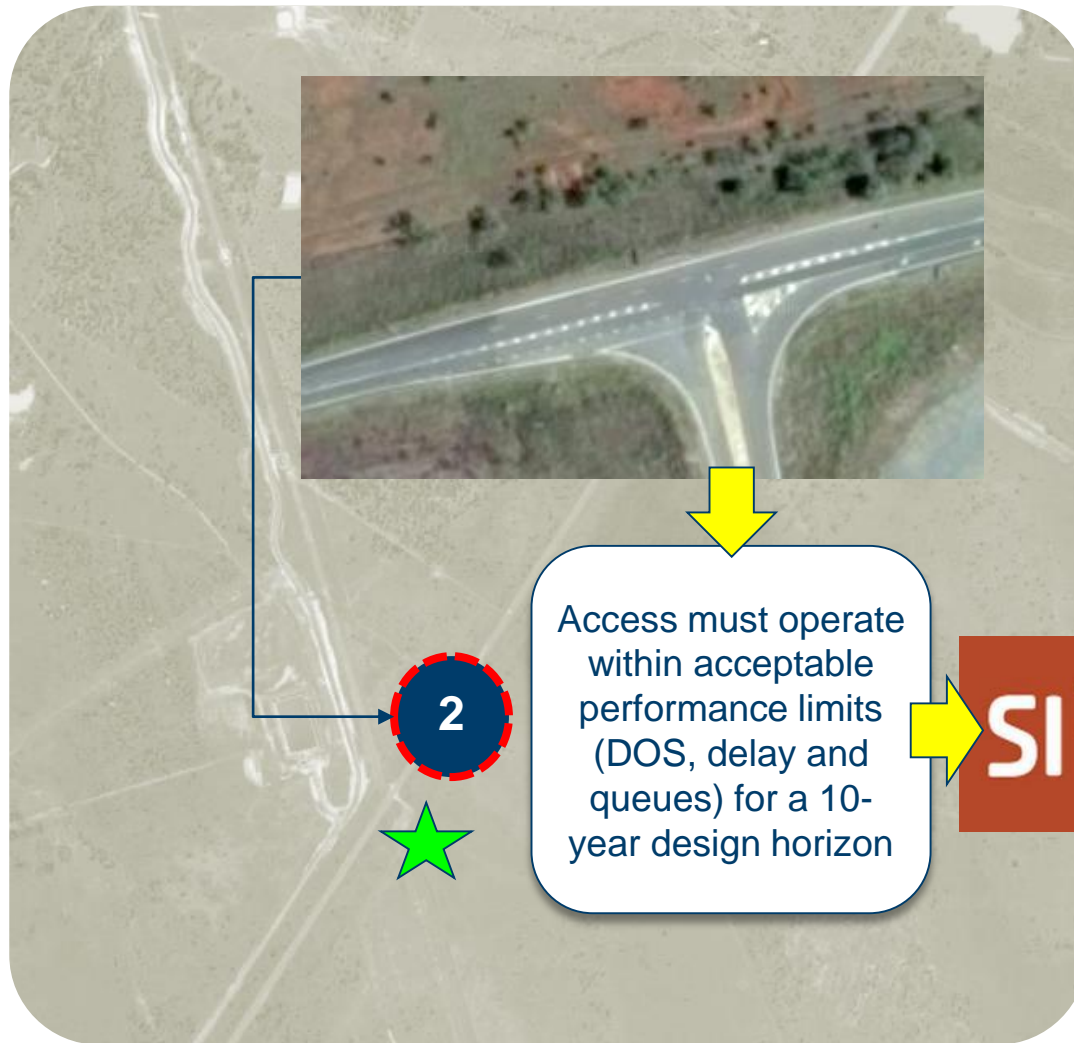
Step 5: Impact assessment and mitigation

TIA Item	Assessment
Intersection Delay Impact Assessment and Mitigation	✓

Scenario	Within Acceptable Limits?
2019 With Development	✓
2029 With Development	✓

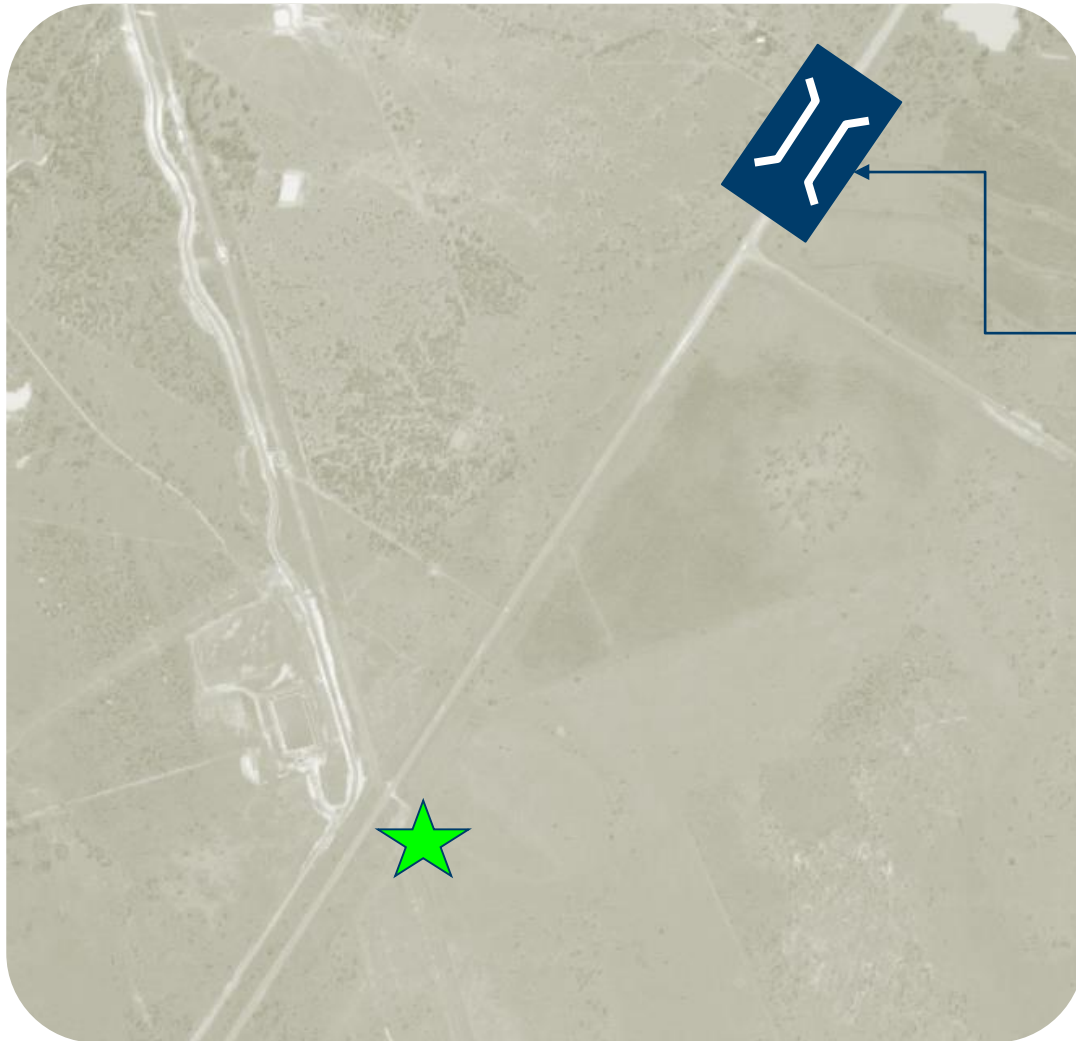
Step 5: Impact assessment and mitigation

TIA Item	Assessment
Transport Infrastructure	✓

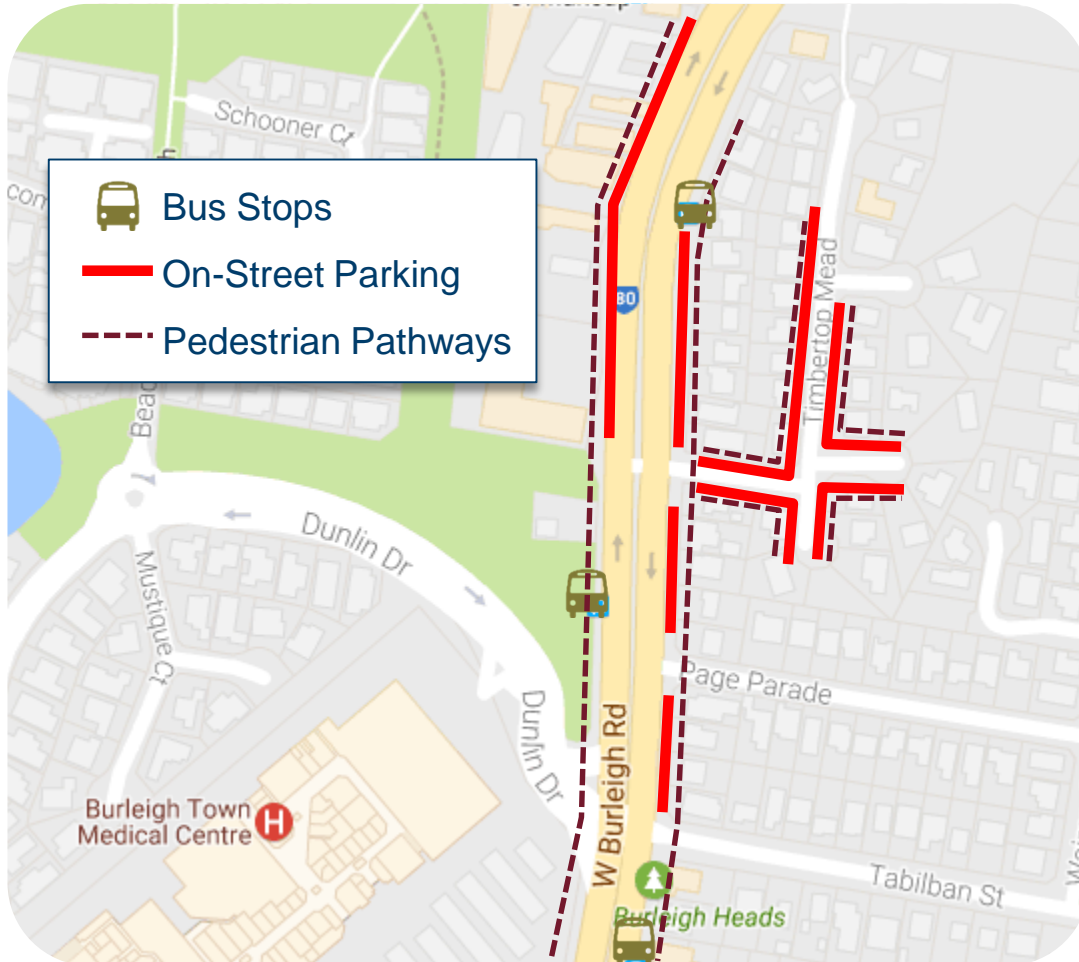
Step 2: Existing conditions

TIA Item	Assessment
Public Transport	✓
Active Transport	✓
Parking	✓
Pavement	NA
Transport Infrastructure	NA

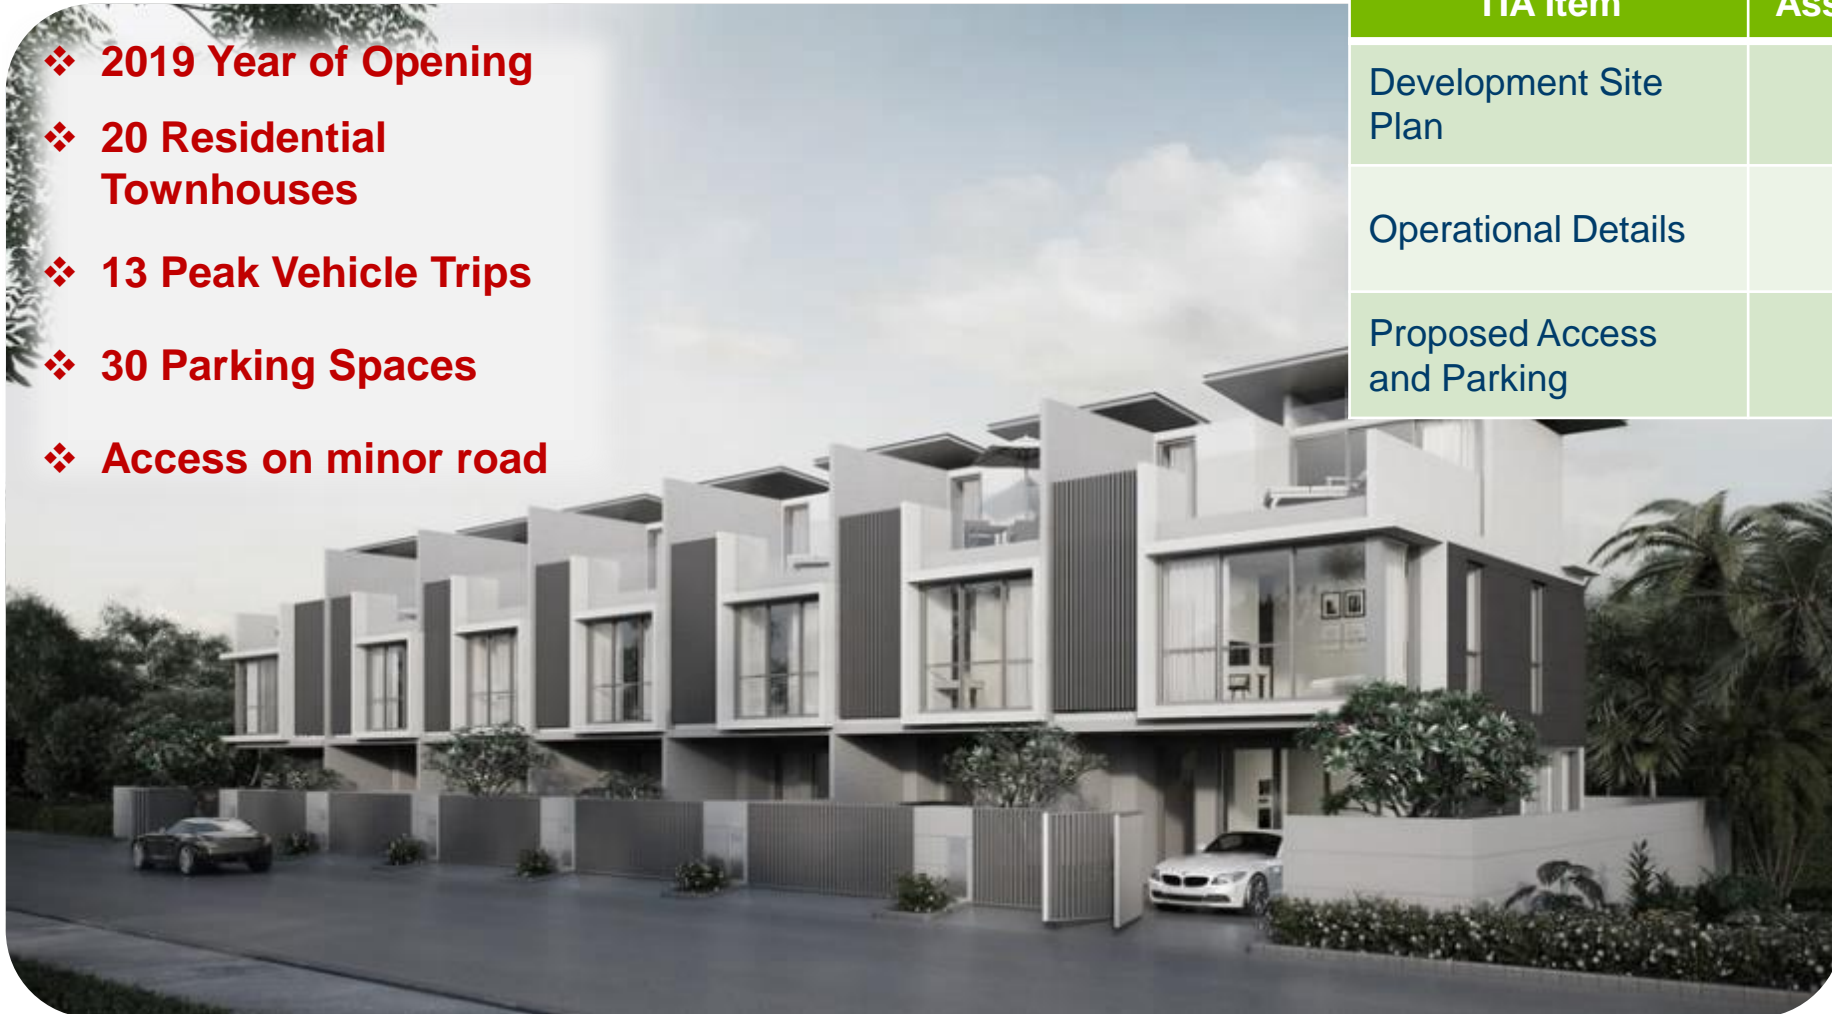
Step 3: Proposed development details

- ❖ **2019 Year of Opening**
- ❖ **20 Residential Townhouses**
- ❖ **13 Peak Vehicle Trips**
- ❖ **30 Parking Spaces**
- ❖ **Access on minor road**

TIA Item	Assessment
Development Site Plan	✓
Operational Details	✓
Proposed Access and Parking	✓

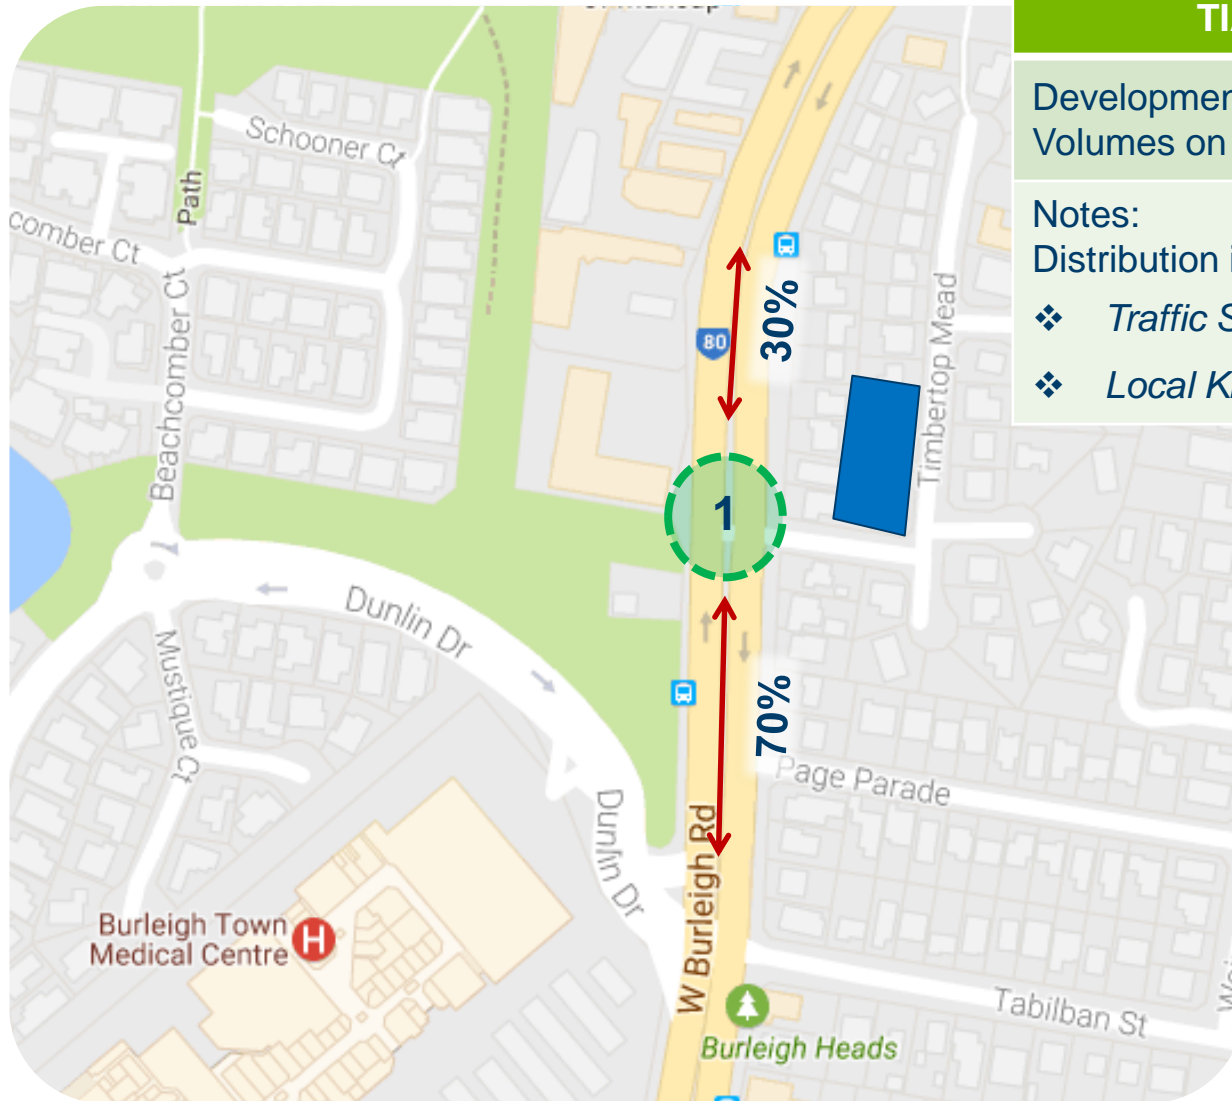
Step 4: Development traffic

TIA Item	Assessment
Development Traffic Volumes on Network	✓
Notes: Distribution is based on:	
❖ Traffic Survey Data	
❖ Local Knowledge
