**Beerburrum to Nambour (B2N) Rail Upgrade Project
Corduoy Road Discovery
Archaeological Assessment Report**

Prepared for TMR

Prepared by Niche Environment and Heritage | 12 December 2022

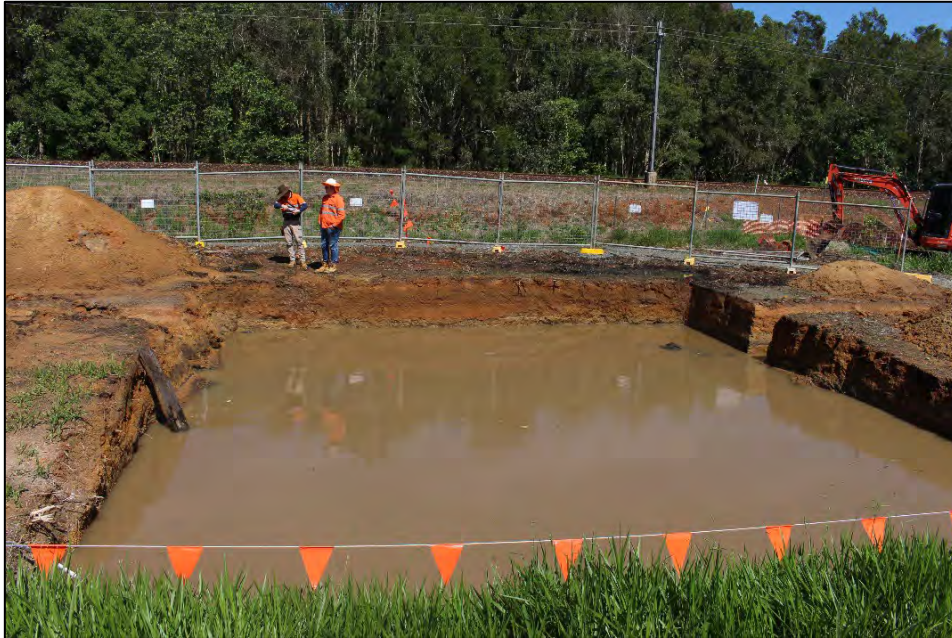
Plate 4. Corduroy road location before water was drained, 28 October 2022.

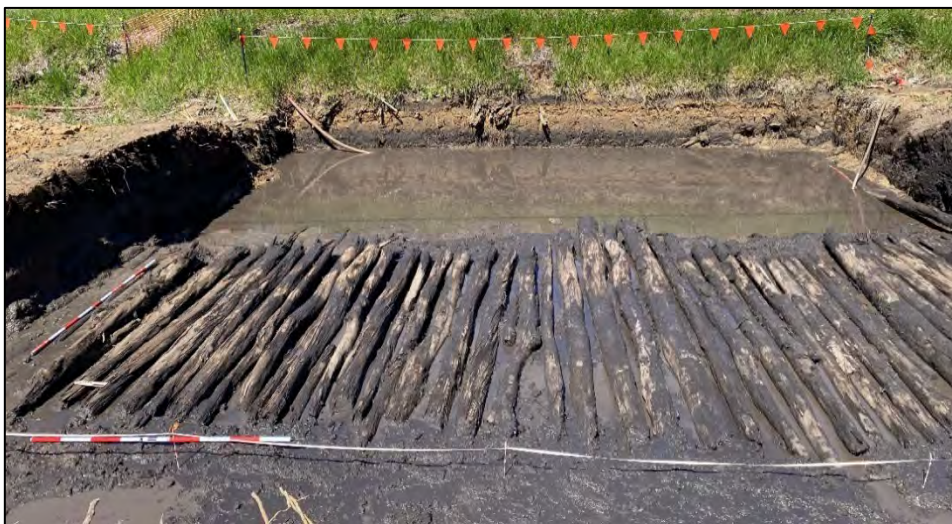
vacuum truck to expedite water removal. Pressurised water spray was used to clear the mud off the corduroy road and this resulted in some tree bark being removed from the logs during this process (Plate 5).

Plate 5. Corduroy road after pressurised water spray was used to expose the corduroy road, 28 October 2022.

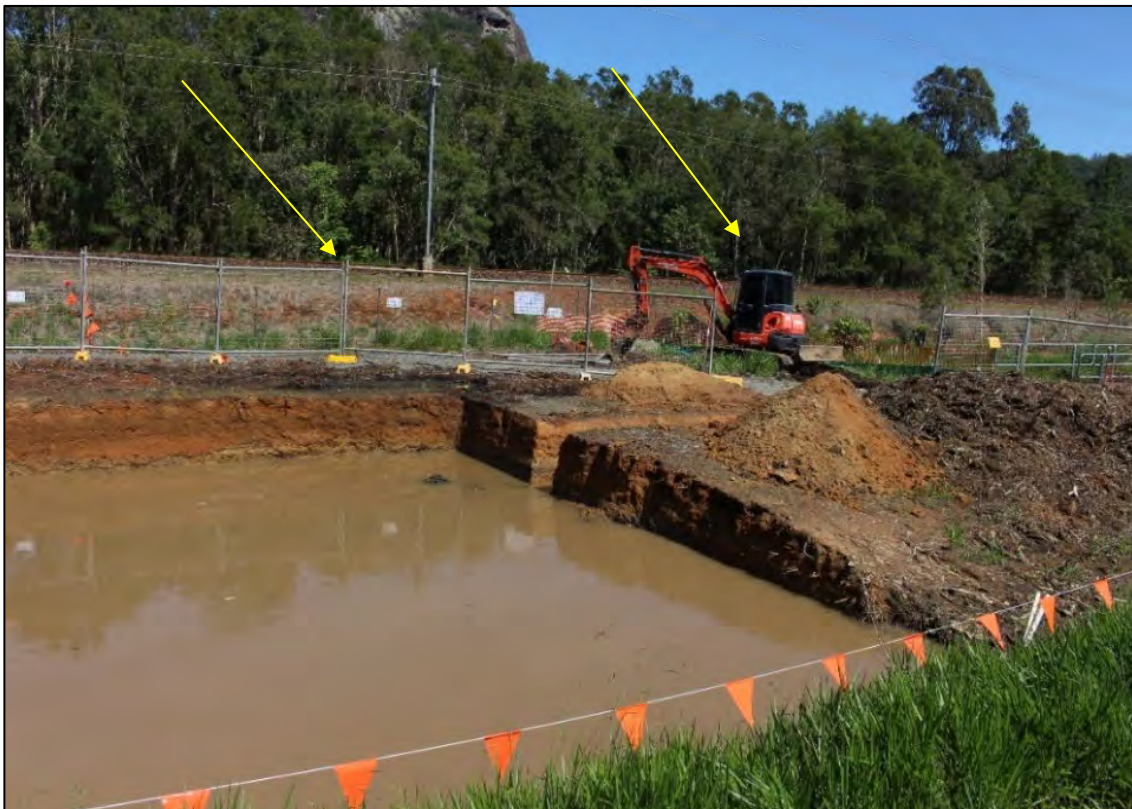
Recent rain had filled the trench with over 18 inches of water (Plate 8) and prior to recording, this had to be drained via a pump and drainage hose and using the vacuum truck. A thick layer of mud covered the corduroy road following drainage and a pressurised water spray was used to clear the mud to facilitate recording (Plates 9 to 12). Some tree bark was lost from the logs during this process.

Plate 8. Location of corduroy road showing water levels, looking west, 28 October 2022. Railway line indicated by yellow arrows.

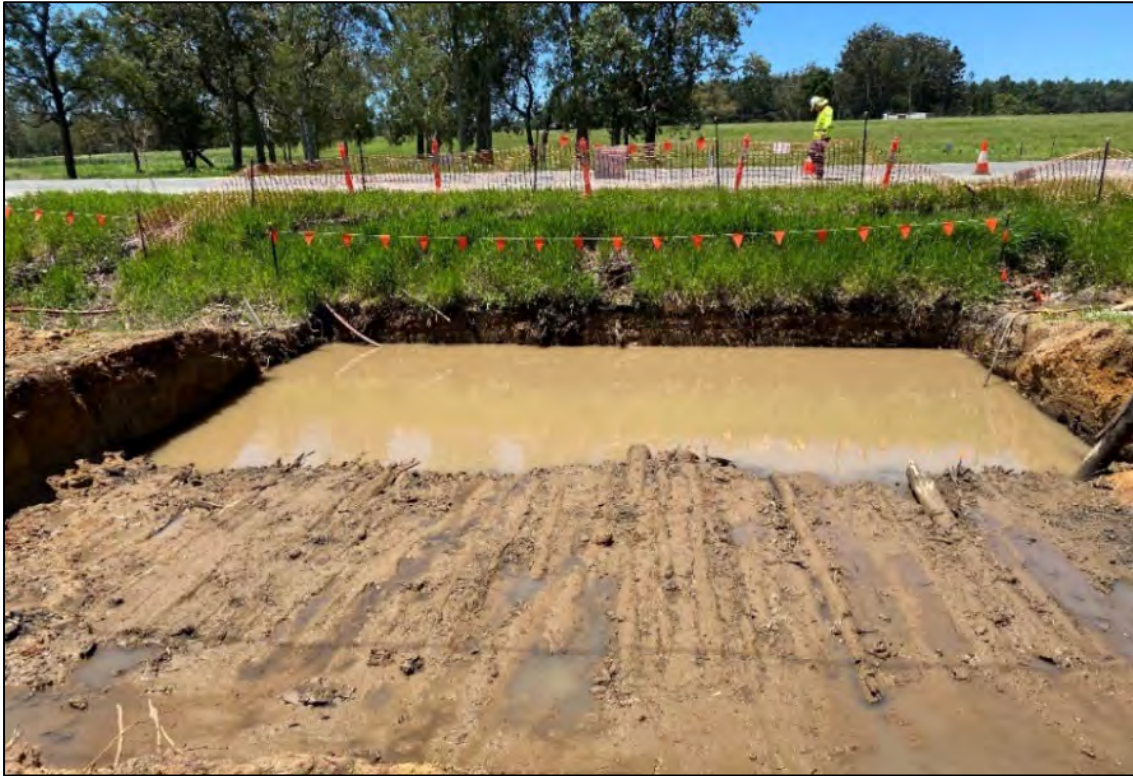
Plate 9. Thick layer of mud covering corduroy road, looking east, 28 October 2002.

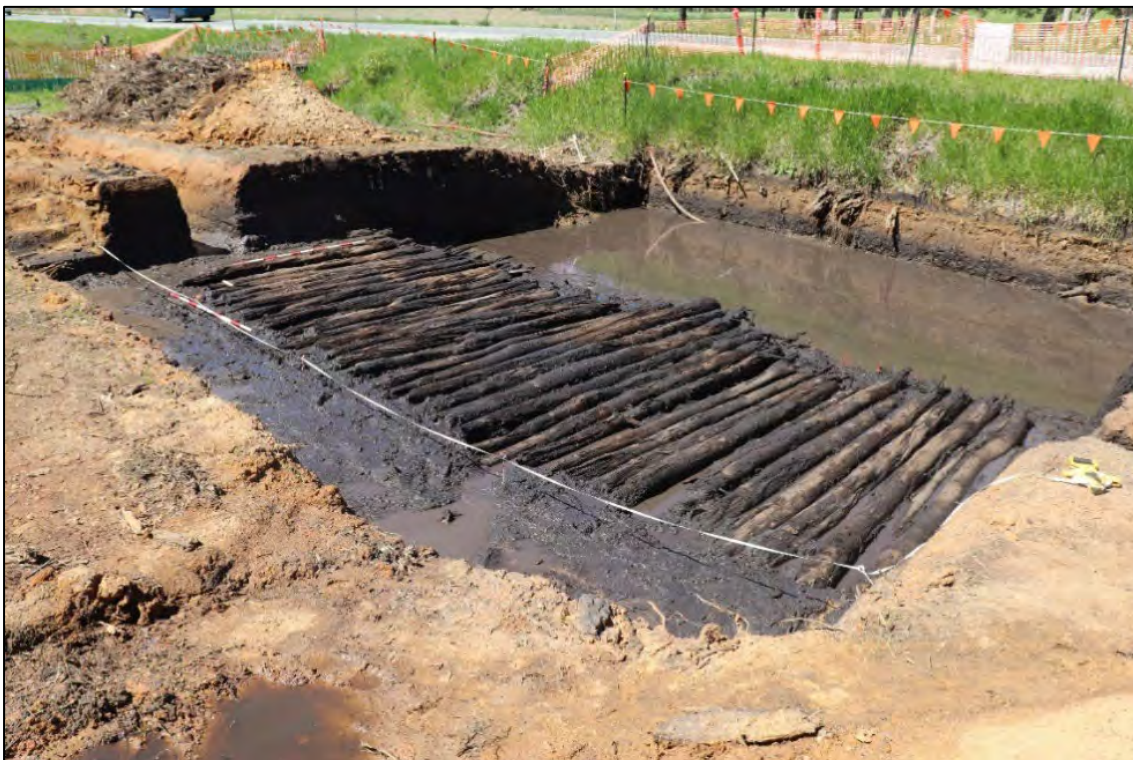
Plate 10. Corduroy road following pressurised water spray to remove mud, looking north east.

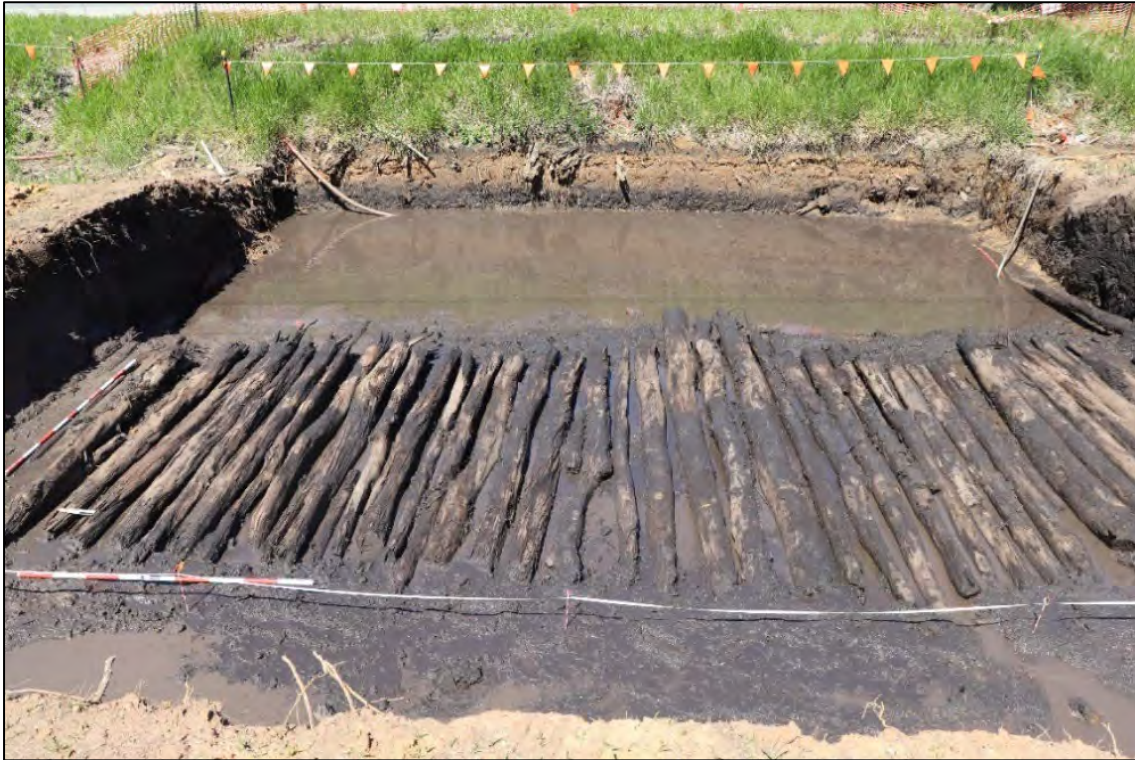
Plate 11. Corduroy road following pressurised water spray to remove mud, looking east. Note lighter areas where tree bark has been lost.

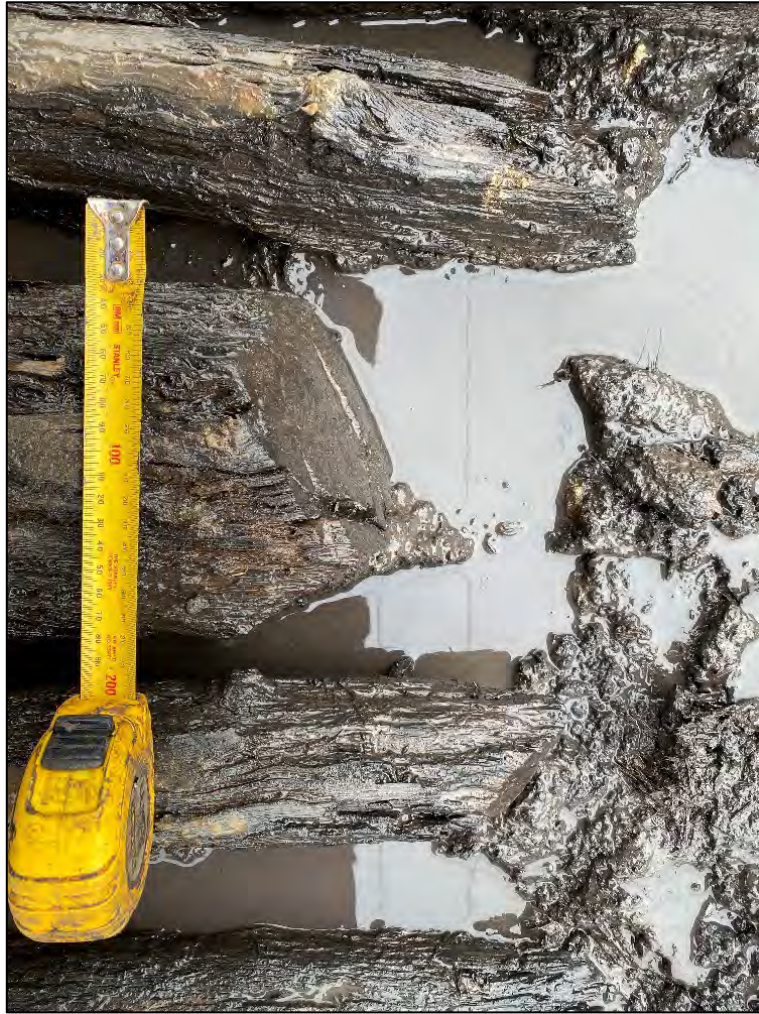
The inspection revealed the feature to be an intact and representative example of a corduroy road. Round, unmilled logs were laid parallel running in an east-west direction with no discernible joinery or carpentry other than obvious axe marks on smaller logs (Plate 12). The corduroy road is in good condition and intact. No signs of rot were identified. Although some outer bark was dislodged during the process of removing the mud layer, delicate edges remained intact after exposure and the logs remained stable and *in situ* during the recording. A TMR drone image showing part of the cleaned corduroy road is provided in Plate 13.

Plate 12. Close up of log ends showing axe marks.

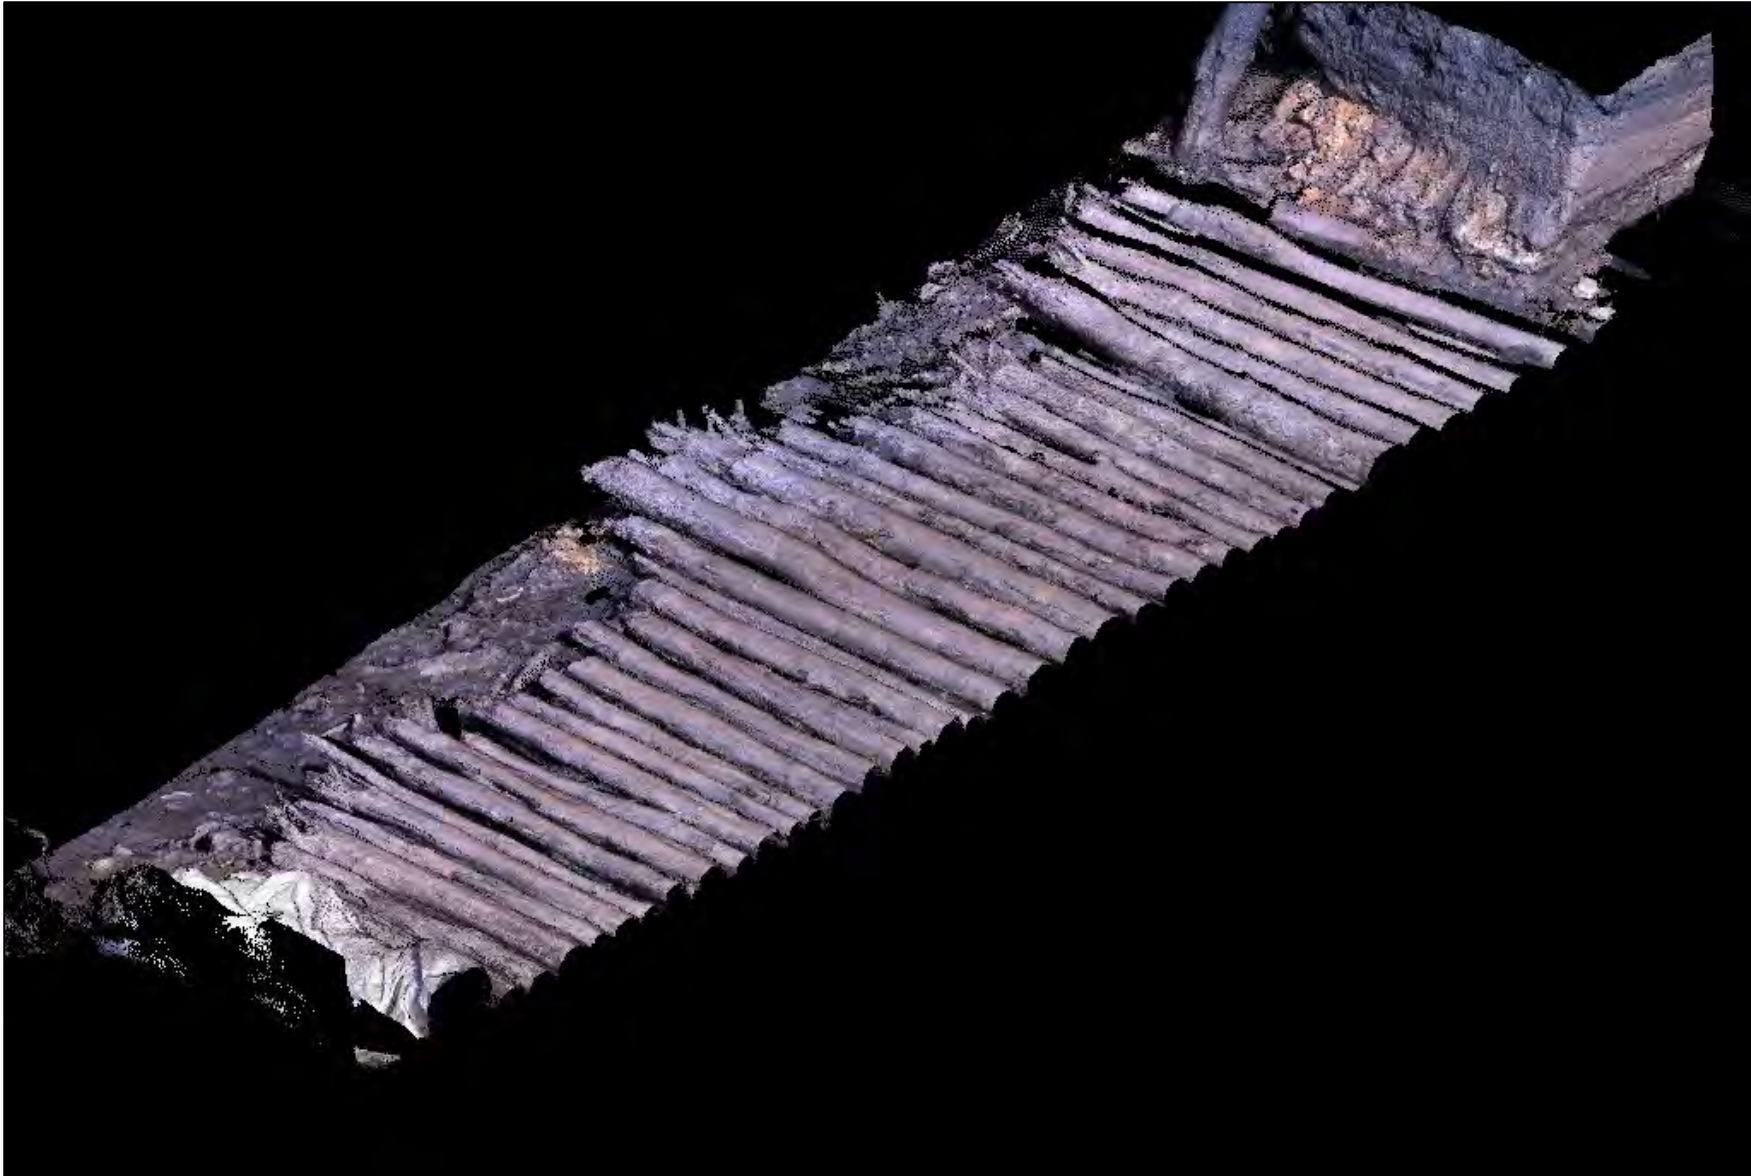
Plate 13. Drone Image with feature extracted, orientation north south (source: TMR).

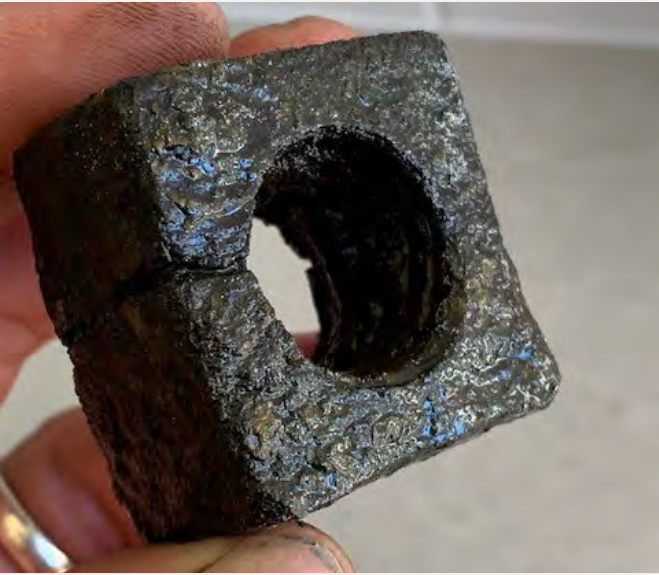
Item	Uses /age	Location/ coordinates	Images (source: TMR)
Metal nut	Unable to be determined	Unknown, in soils near corduroy road

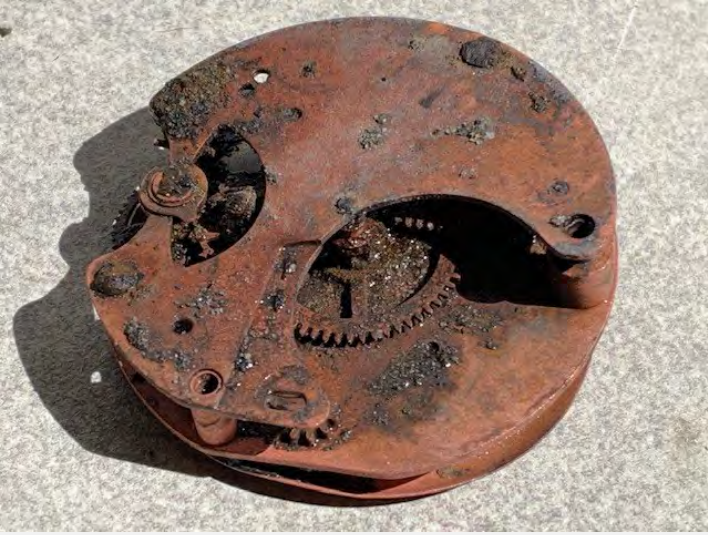
Pocket watch gears, no case	Unable to be determined	Unknown, in soils near corduroy road

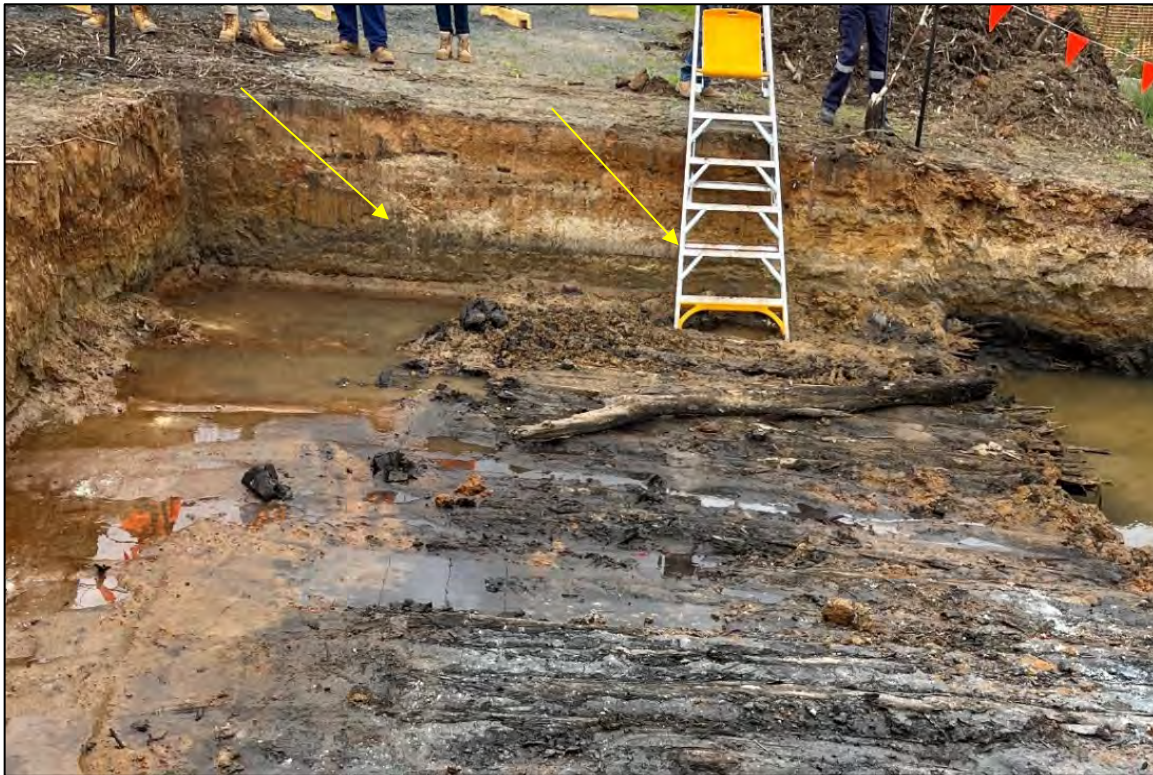
The site stratigraphy showed processes of deposition associated with the both the 1937 highway and the later 1967 upgrade. A layer of asphalt, used to surface the 1937 highway is seen in the site stratigraphy approximately 40 cm above the corduroy road (Plate 14). Above this, the stratigraphy becomes more difficult to define however, it appears that the area was filled to provide more stability and lessen the slope of the gully west of the 1967 highway upgrade.

Plate 14. Trench stratigraphy northern wall, looking north. Asphalt layer from 1937 road construction indicated by yellow arrows.

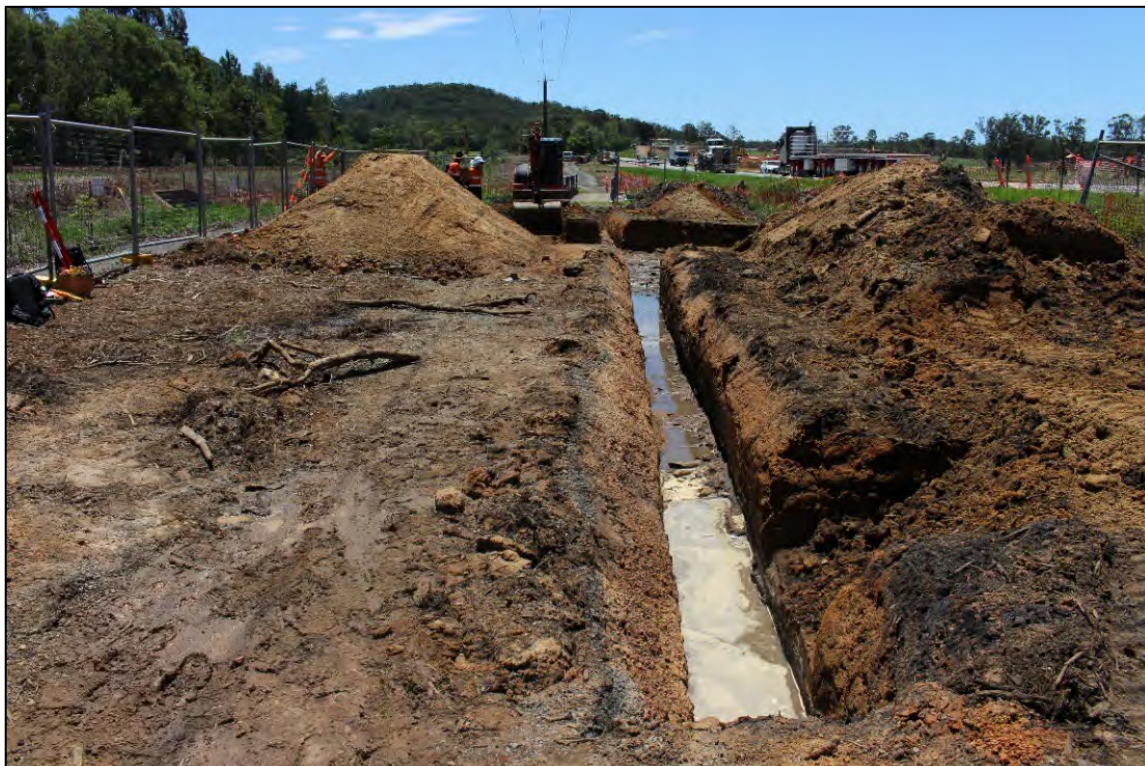
Previous investigations by TMR determined the extent of the corduroy road in the vicinity of Project works through a series of strip trenches and small pits between 20 cm and 1 m wide and revealed that the feature extends approximately 40 m – 50 m (Plate 15).

Plate 15. Strip trench showing southern extent of corduroy road indicated by yellow arrow, looking north.

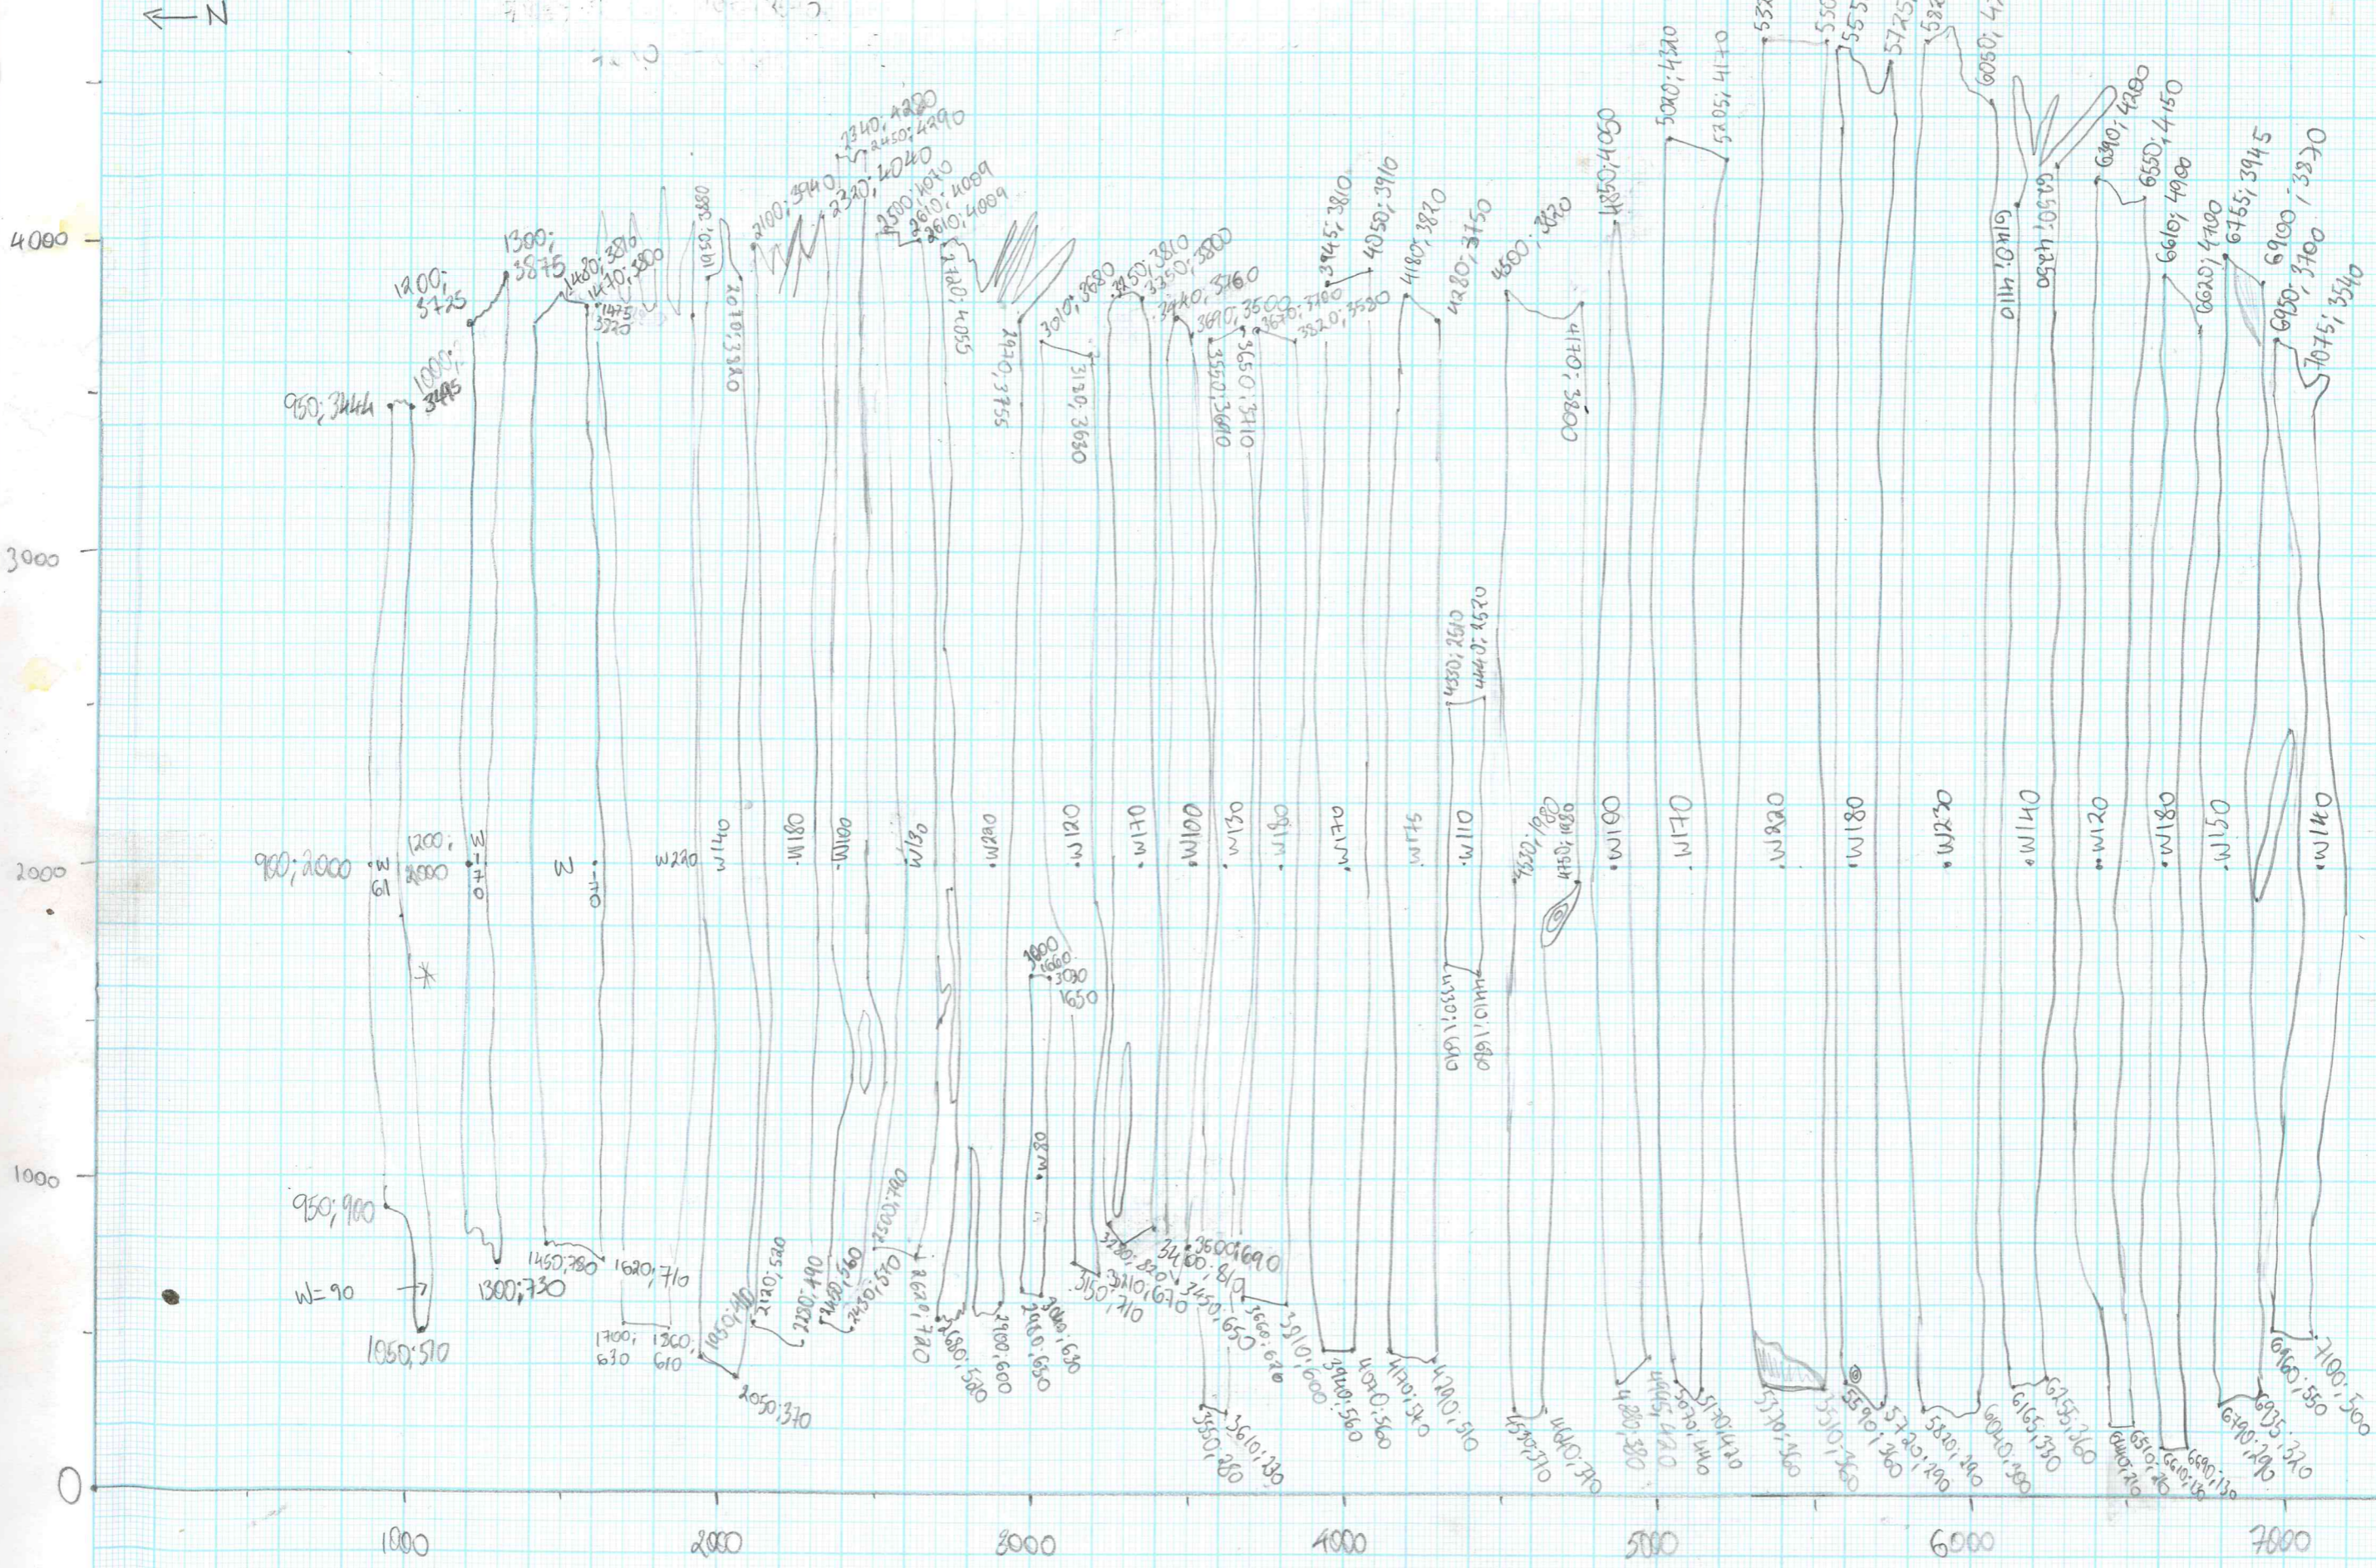
#6105 BAN - Corduroy Road - 28/10/22 / 1/11/22

Log sizes vary. The smallest logs were recorded at around 600 mm long with a central diameter of 50 mm and the largest at 3900 mm and 4200 mm long with diameters of up to 230 mm (see Appendix A).

Baseline; Offset Measurements in mm
